NATIONAL PROGRAM FOR INSPECTION OF NON-FEDERAL DAMS
BARDEN RESERVOIR DAM (..(U) CORPS OF ENGINEERS WALTHAM
MA NEW ENGLAND DIV MAR 80

reads: Phase I Inspection Report, National Dam Inspection Program; official title of the program is: National Program for Inspection of dams; use cover date for date of report.

OVERVIEW PHOTO - BARDEN RESERVOIR DAM

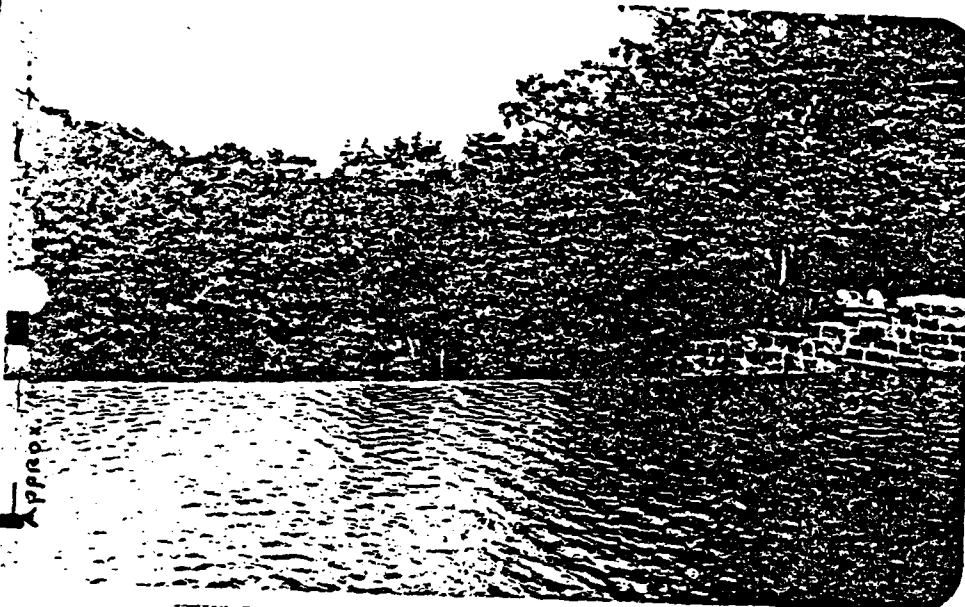
PHOTO #2.

General view across crest of spillway. No significant irregularities noticeable across entire crest.

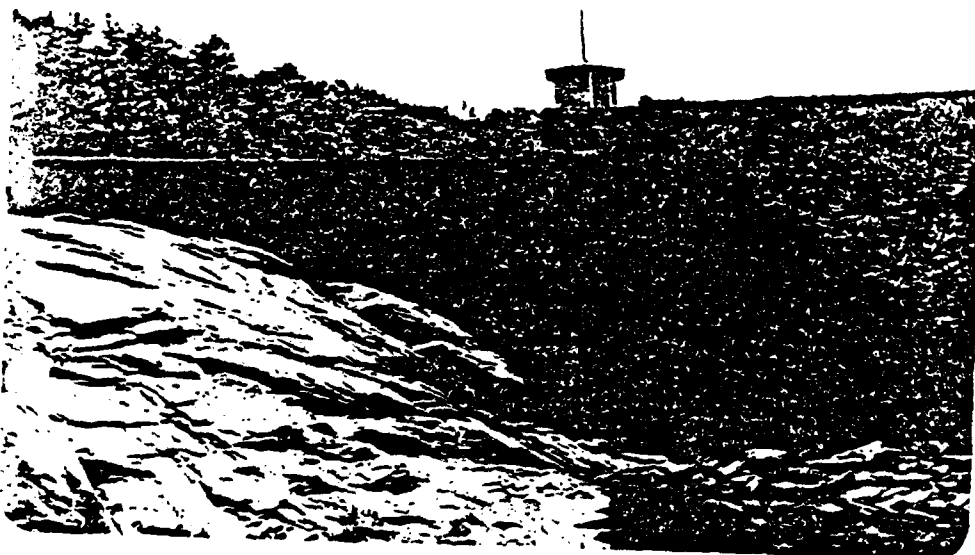
PHOTO #3.

General view of face of spillway, heavy masonry abutment wall & ledge outcropping.

Only a trickle of water passing over spillway this date.

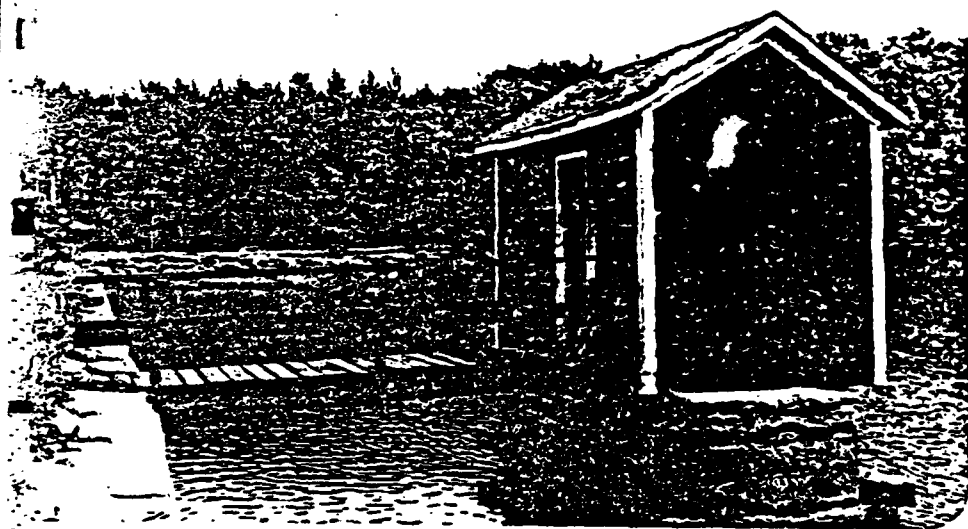
PHOTO #5.

View of gatehouse in center of dam embankment. Access bridge appears to be of recent construction and in good condition.

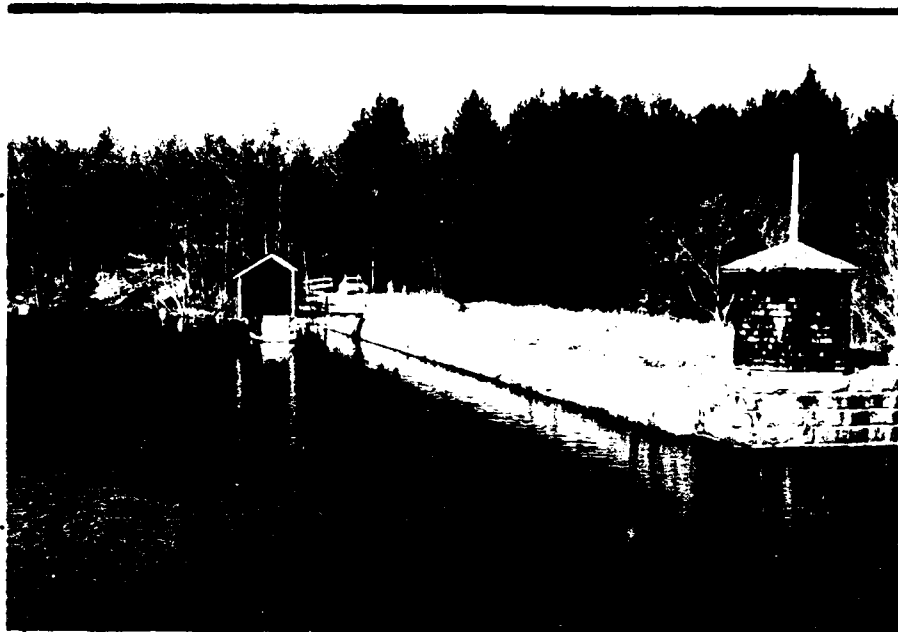
2. Upstream Slope - From Sta 0+00 to Sta 2+49 there is a vertical mortared stone wall above the water level. The wall is in good condition and alignment. The top of the wall is 5 feet above the spillway elevation and about 18 inches below the crest of the dam. A grassed slope extends from the top of the upstream wall to the crest. The upstream slope below the masonry wall was entirely submerged at the time of inspection. Riprap could be observed on the slope to a depth of 2 to 3 feet below the water surface and appeared in good condition. (See photos C-1,2)

PHOTO C-1 - Upstream Face of Dam looking from Right Abutment Area.

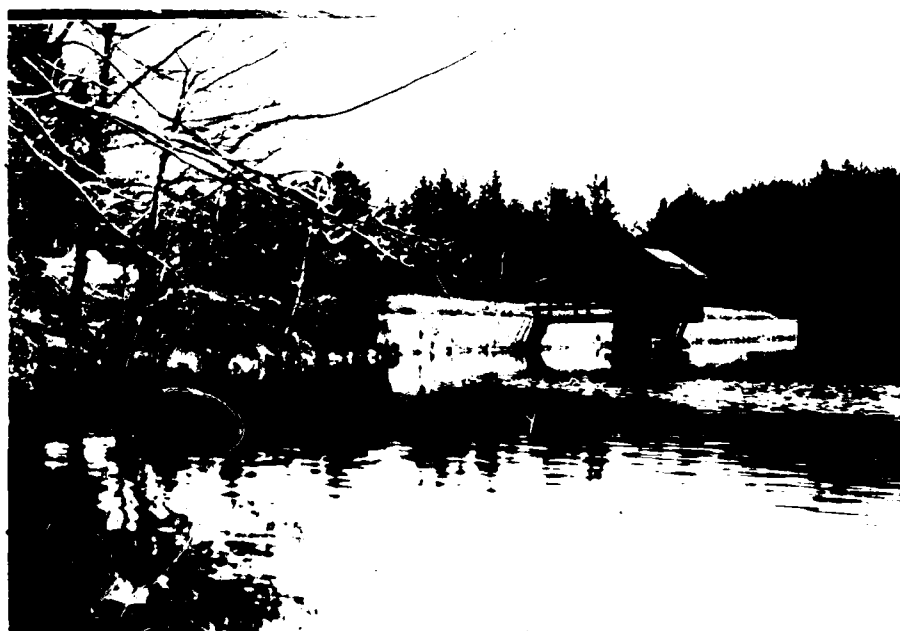
PHOTO C-2 - Upstream Face of Dam looking from Left Abutment Area.

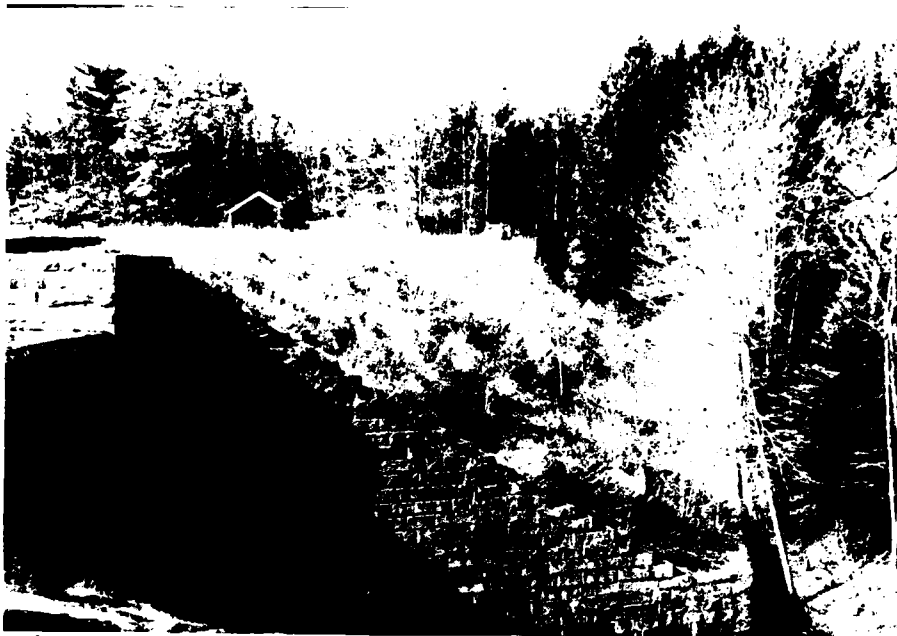
1. Spillway and Training Walls - A stone masonry uncontrolled overflow spillway is located at the right abutment of the dam. The spillway weir is constructed of large granite slabs placed in a slight upstream arc (81.5 feet) that is founded on a large exposed bedrock formation. The approach channel to the spillway is open with the easterly training wall extending upstream approximately 200 feet providing protection against wave action for Hemlock Road. Downstream below the weir crest, the channel is confined within cut stone masonry training walls and the channel bed is the exposed bedrock monolith. (See photos C-3, 4, 5.)

PHOTO C-3 - Downstream Slope of Dam looking from Right Abutment Area.

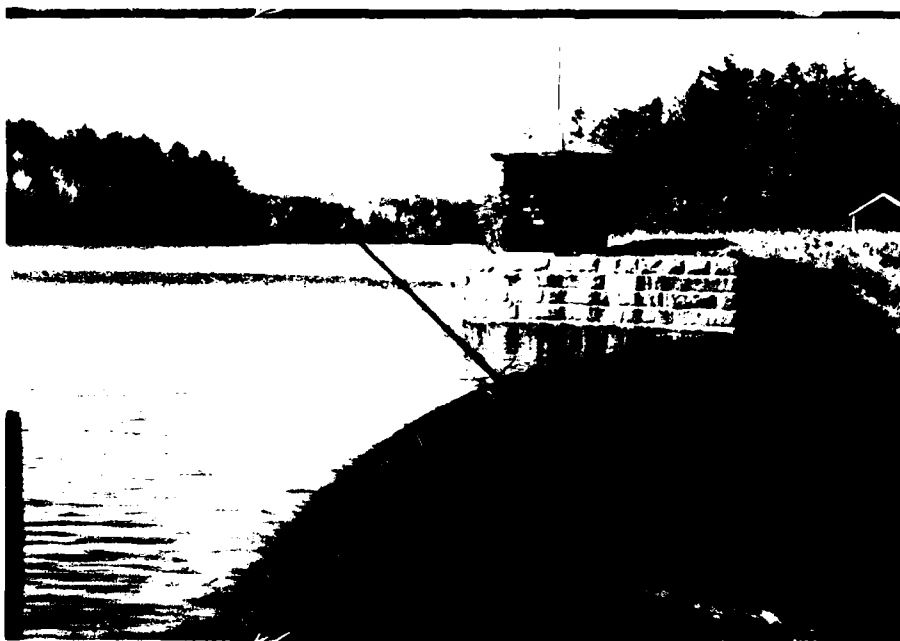
PHOTO C-5 - Overflow Spillway looking from Right Abutment Area.
